# CERAMIC REGENERATOR SYSTEMS DEVELOPMENT PROGRAM

PROGRESS REPORT FOR PERIOD JAN. 1, 1978 TO MAR. 31, 1978

J. A. COOK, C. A. FUCINARI, J. N. LINGSCHUIT, C. J. RAHNKE,  
AND V. D. RAO

RESEARCH STAFF  
FORD MOTOR CO.  
DEARBORN, MICHIGAN 48121

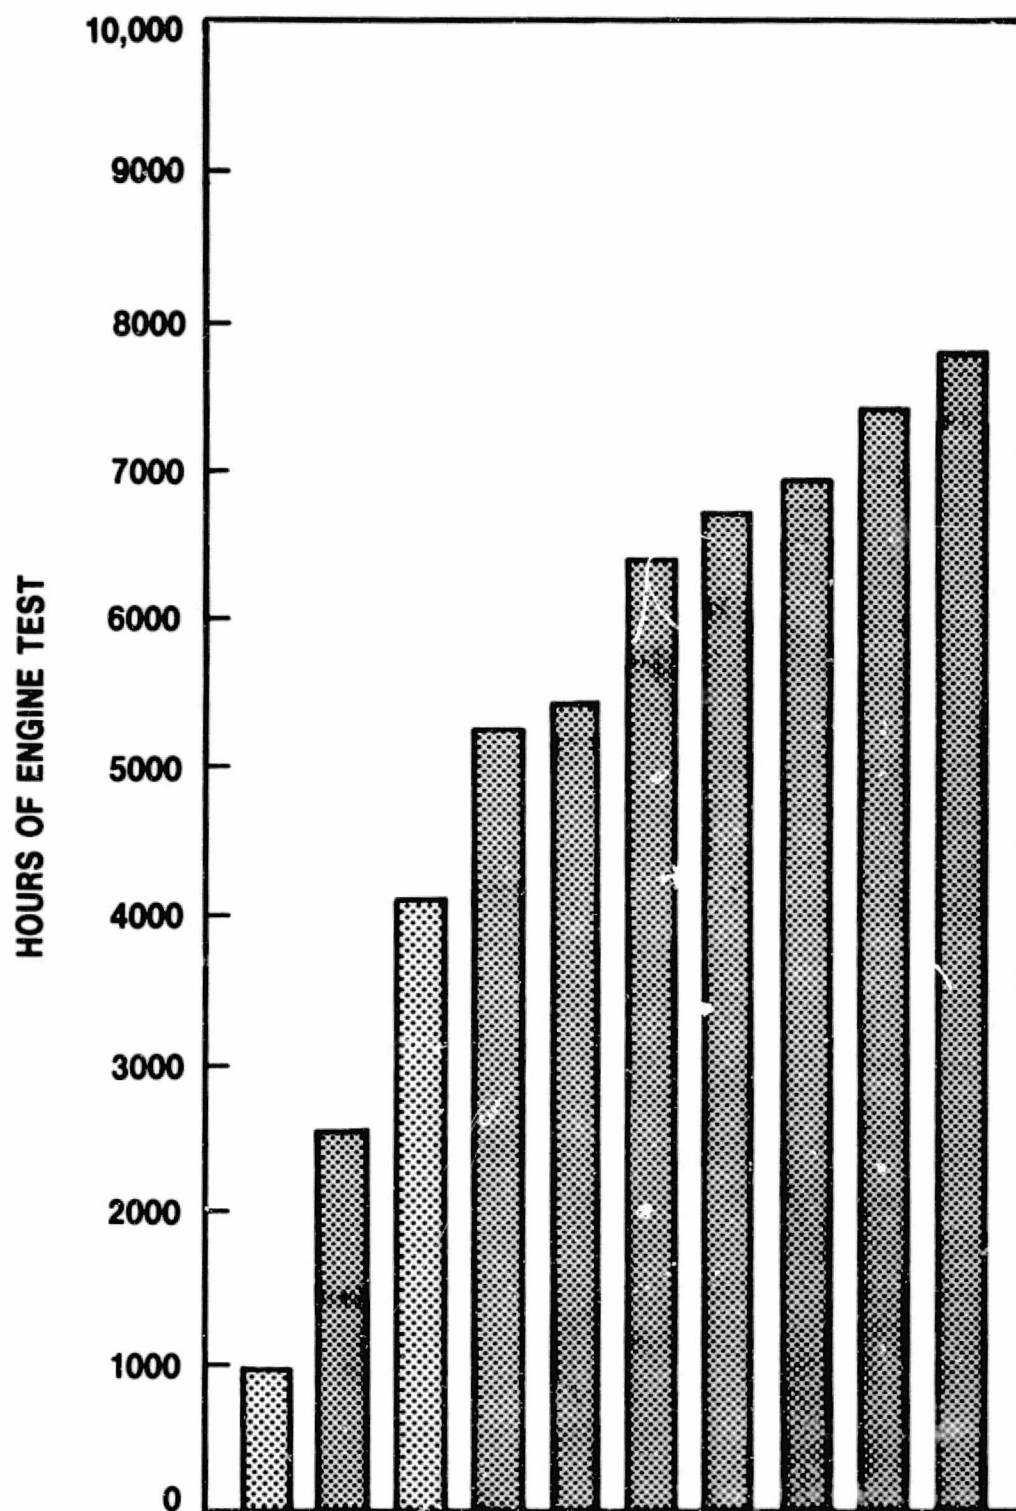
Ten thick-wall AS cores are being tested at 800°C (1472°F) under identical operating conditions and these cores make up the control sample on which durability projections will be based. The durability status of these cores is shown in Figure I.B.1.1. All cores have acquired at least 985 hours of engine durability. About 52,000 core hours of engine test have been accumulated on this aluminum silicate sample with the highest hour core having attained 7804 hours. At least two failures are required before a Weibull Failure Analysis can be undertaken. There have been no failures of cores made from this material so a failure analysis cannot be started. A reliability projection, however, can now be made if the shape of the Weibull failure curve is estimated. Using Weibull theory and a sample consisting of the seven, highest-hour AS cores, together with an estimated failure curve slope, a B<sub>10</sub> life of 5000 hours can be projected with 59% confidence. With the same theory, a B<sub>10</sub> life of 3500 hours can be projected for AS material with almost 100% confidence. A B<sub>10</sub> life of 3500 hours might be acceptable for an automotive application.

Figure I. B. 1. 1 Durability Record of Thick-Wail AS Regenerators Operating at 800°C (1472°F).

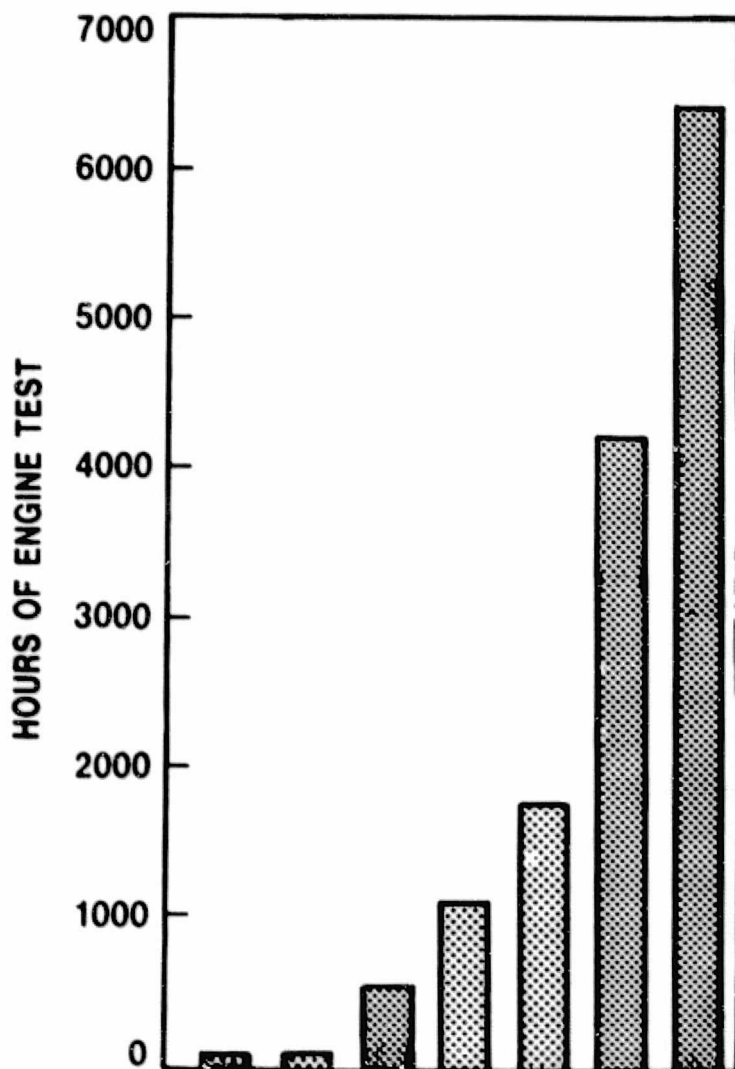
Seven thin-wall AS cores have also been engine tested at 800°C (1472°F) as shown in Figure I. B. 1. 2 and one core has accumulated over 6388 hours.

Durability Record of Thin-Wall AS Regenerators  
Operating at 800°C (1472°F).

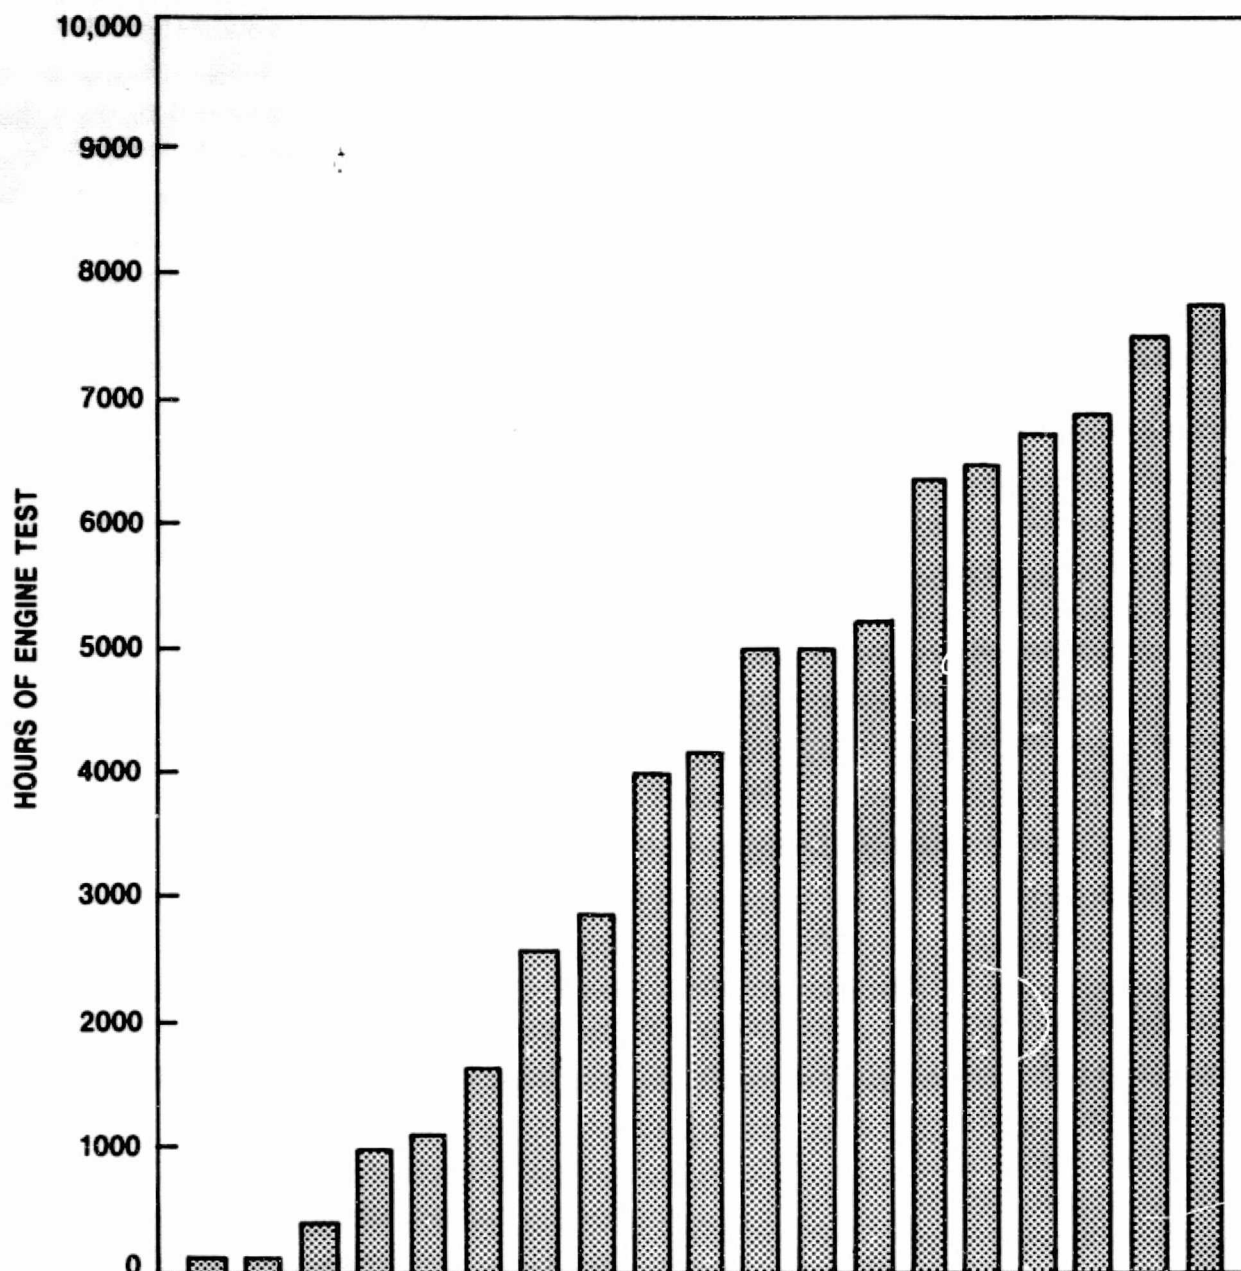
The running history of all of Supplier A's AS cores that have been engine tested are shown in Figure I. B. 1. 3. This figure also includes the two cores tested at 1000°C (1832°F) and described in Section II. B. Almost 71,000 hours of engine test have been accumulated on this material. None of these cores show any serious signs of thermal distress or chemical back damage. To date, a total of eleven AS cores have each accumulated over 4,000 hours and six cores have each accumulated over 6,000 hours of engine test without visual distress.

Figure I. B. 1.3 Durability Record of All AS Regenerators Tested in the Ford 707 Turbine Engine.

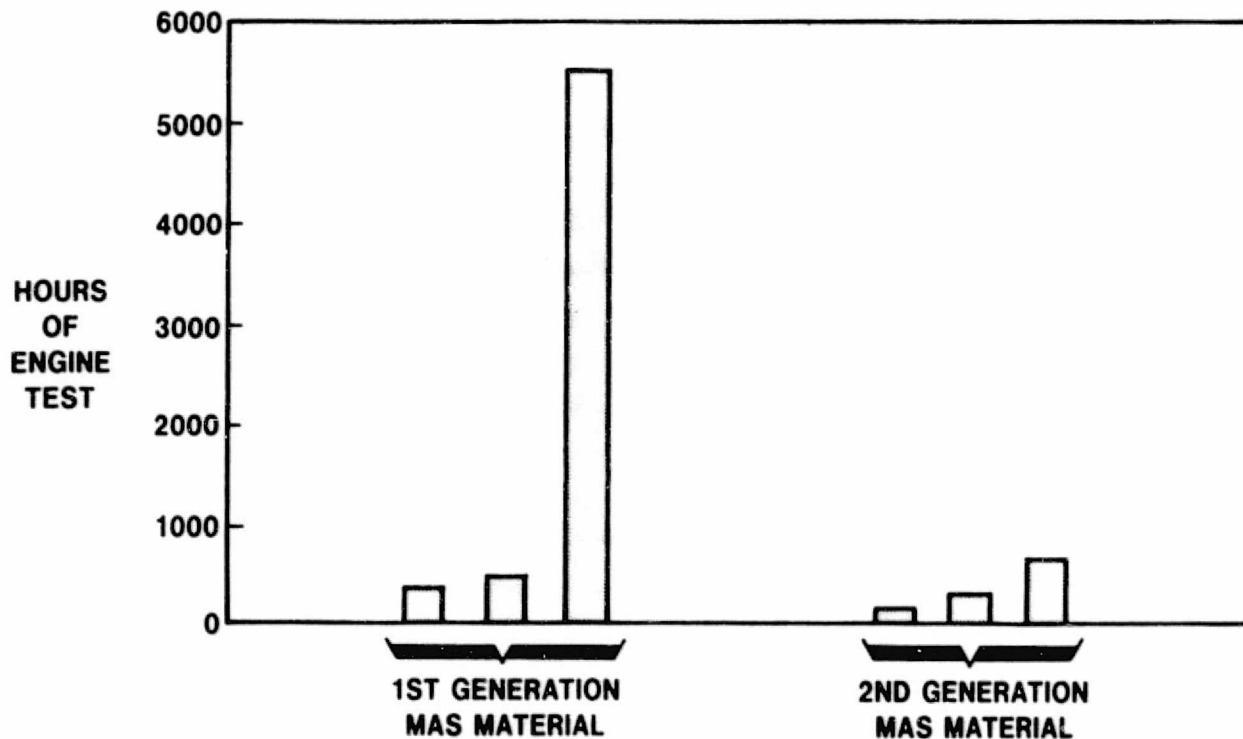
Figure I. B. 2. 1      Durability Record of First and Second Generation MAS Regenerators.

Engine tests of two early MAS regenerators fabricated by Supplier D are described in Reference 1. The testing of both of these cores was terminated when the cement holding the hubs or center sections in place failed and caused damage in this region. Subsequently, an improved procedure for bonding the center insert to the rest of the matrix was developed and used on a third core provided by Supplier D. This core was evaluated in both the accelerated chemical attack engine test and long-term engine durability tests (Reference 2 and 3). The cement holding the center insert in place has failed, but the core has now accumulated 5381 total hours of engine test (Reference 4).

Thermal stress cracks developed in the third core after 200 hours of engine operation, but remained stable throughout the rest of the test. An analysis conducted on this MAS material showed that at the operating temperature of 800°C (1472°F) the rim thermal stress safety factor could be substantially below unity. The material in the rim area therefore, would be expected to fail and develop thermal cracks (Reference 4).

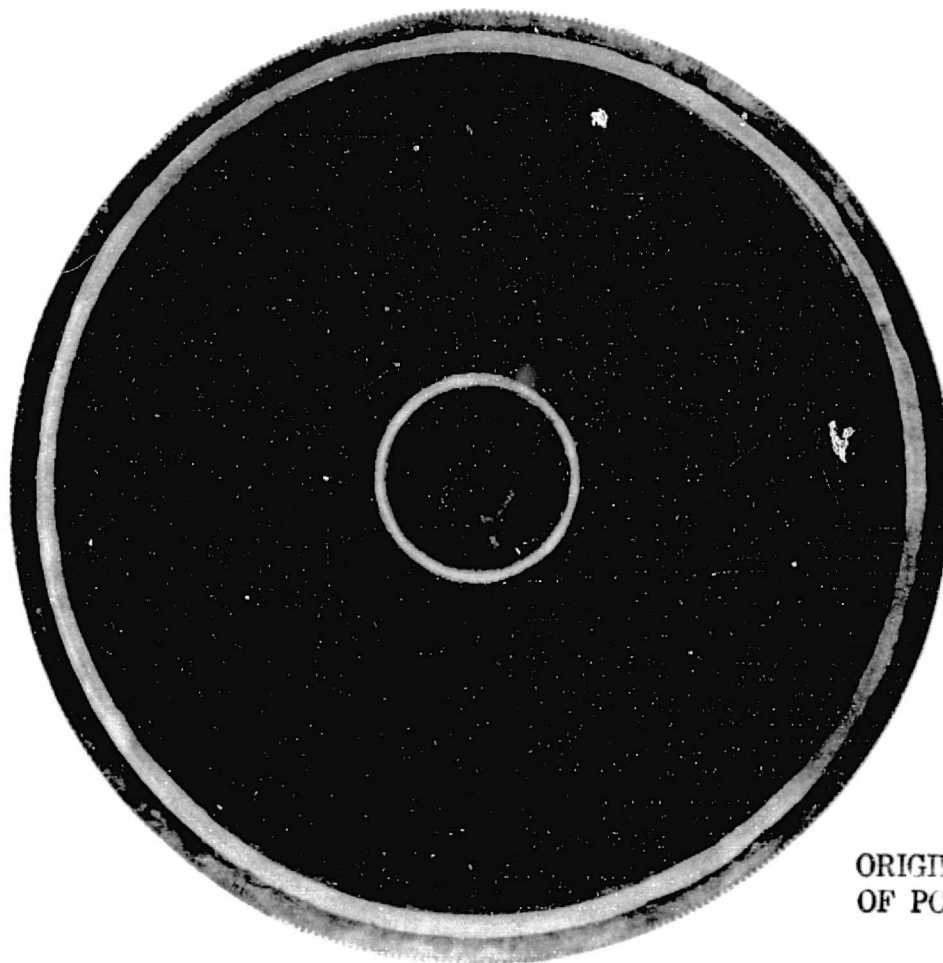
As reported in References 2 and 3, the cement holding the hub insert in place failed in five different AS cores out of 19 that have been engine tested in the 707 turbine. These cores, which were both thick and thin-wall, had accumulated between 68 and 4750 hours at the time of failure. In each case, the failure was attributed to improper composition or improper processing of the cement itself.

Several different concepts aimed at correcting this problem have been engine tested (Reference 3) and the most successful configuration is shown in Figure I.B.3.1. In this arrangement, the hub is cemented into a thin, 6.4 mm (.25 in) wide, solid ceramic ring and this sub-assembly is then cemented into the matrix. The ceramic ring allows better control of temperature during the firing of the cement, and it also provides a better match of the thermal expansion characteristics of the insert-matrix bond area to the rest of the matrix.

All currently active AS cores that have undergone hub failures have been repaired to this configuration, and all new cores received from Supplier A have been built with this design. As a result, six cores with this new hub configuration have been on durability test since late 1976, and their durability record is shown in Figure I.B.3.2. One of these cores has accumulated over 4300 hours. One low-hour failure occurred during 1977, and after extensive investigations the cause of this failure is still unexplained.

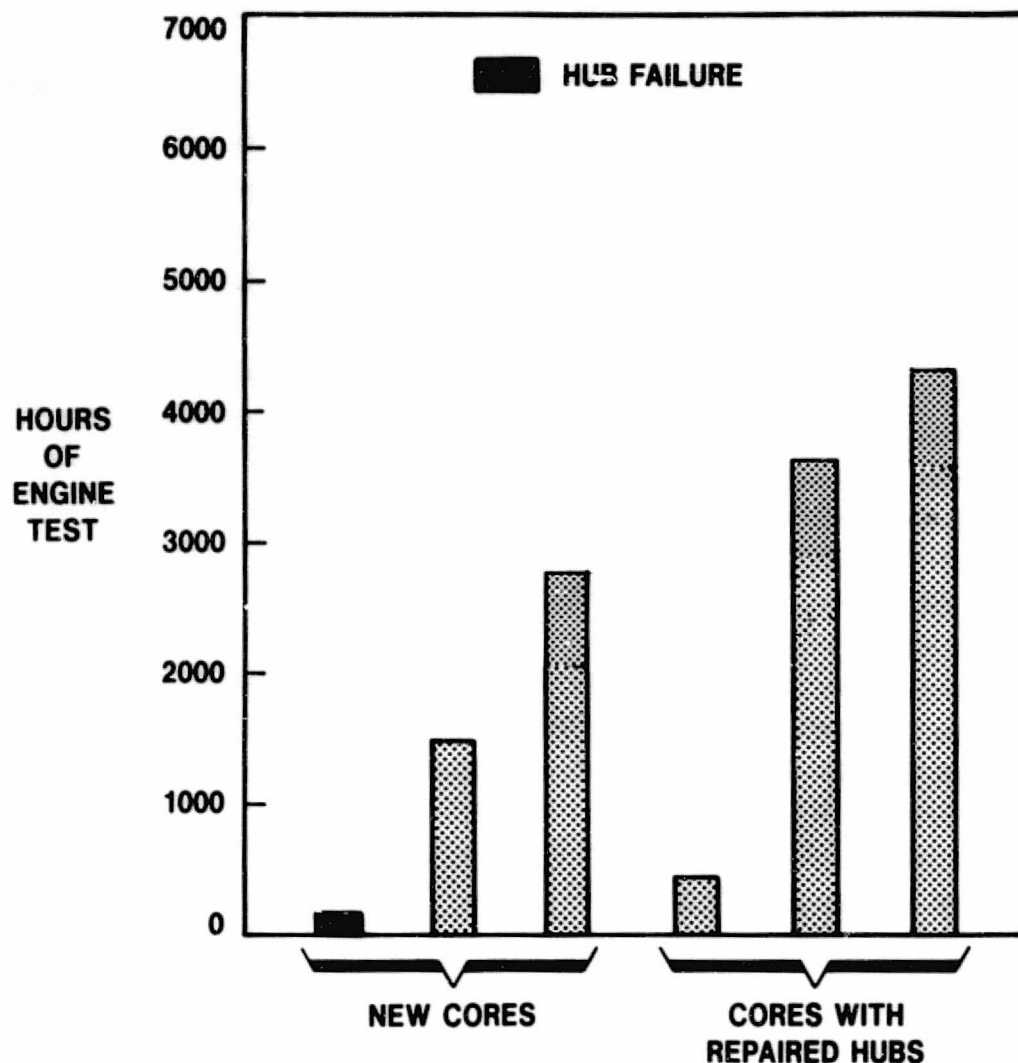
Figure I. B. 3.2 Durability Record of Cores with Solid Ceramic Ring Around Hub Insert.

These hub failures are still not considered to be a serious, fundamental problem. Hubs utilizing a solid ceramic ring around the hub insert have been fabricated into several AS cores, and their durability record appears better than the original hub configuration. More engine test hours are needed to determine the durability life of this concept.

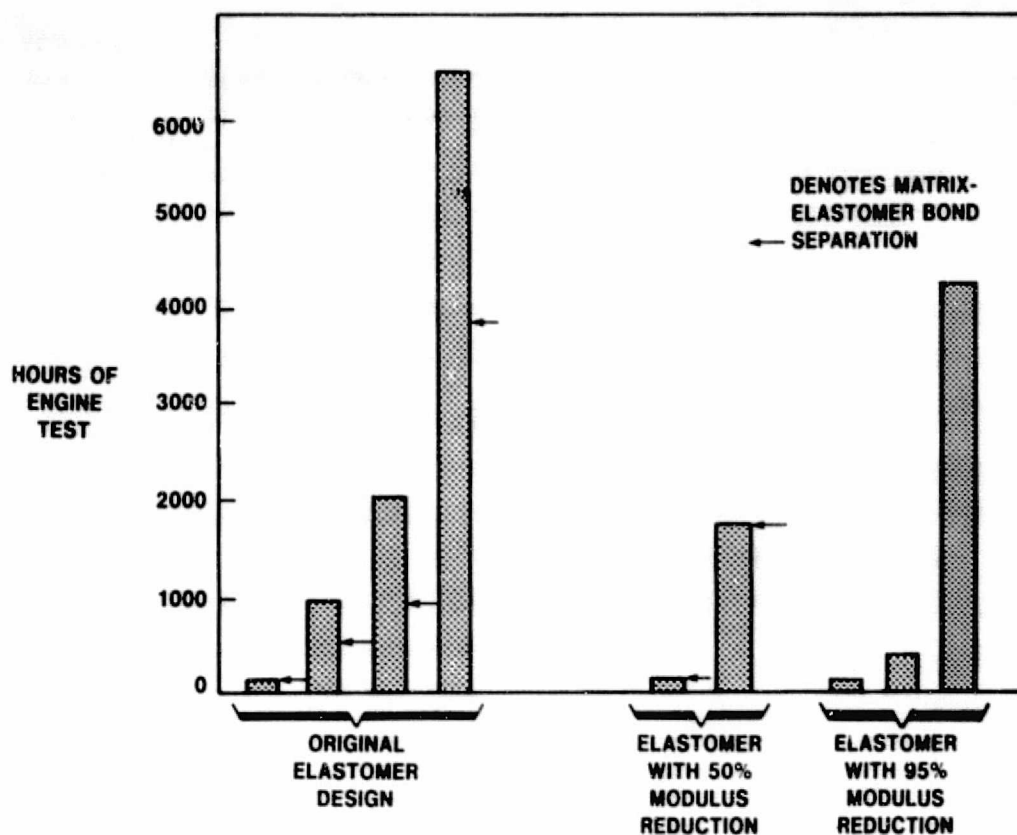
Figure I. B. 4. 1 Durability Record of Thin-Wall, AS Regenerators Utilizing Different Elastomer Bonding Approaches.

Reasonably good durability has been obtained with the elastomer bonded ring gear on the thick-wall AS cores. The results obtained with the same elastomeric drive on the thin-wall AS core have not been as successful. Since the thin-wall matrix has a thinner cross section, it is weaker and has less capability for carrying thermal and mechanical loads. Every thin-wall AS core, bonded with the same procedure used with the thick-wall cores, has had a separation in the elastomer-matrix bond area. The operating history is shown in Figure I.B.4.1. Experimental and analytical evidence presented in Reference 4 shows that the eventual solution to this problem is the development of a high-compliance, elastomer system in which the modulus of the elastomer is reduced at least 70%. This conclusion is supported by engine operating experience, also presented in Figure I.B.4.1, which shows that a 50% reduction in modulus is inadequate and failures will occur with this arrangement.

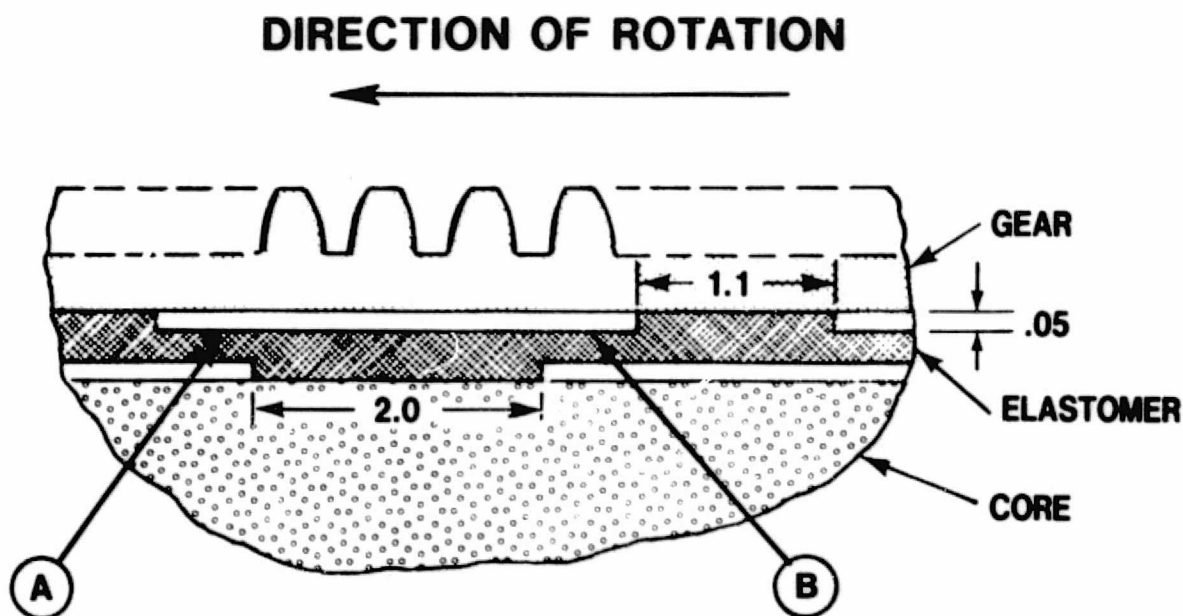
Figure I. B. 4. 2 High Compliance Elastomer Design.

Although the elastomer matrix bond area is still intact, a failure of the elastomer itself has occurred in the high-hour assembly. If the gear shown in the lower half of Figure I.B.4.2 moves from right to left, the drive torque will be transmitted as a tensile load through that portion of the elastomer marked "A" and as a compressive load through that portion marked "B." All of the tensile load carrying members, "A," have failed in the long-life assembly, and for the last 800 hours the drive torque has been transmitted by the compressive load members only. The cause of these elastomer failures is being investigated, but apparently they do not disturb the functional behavior of this concept.

Three regenerator assemblies are now on test in which the modulus of the elastomer has been reduced by 90-95%. One of these assemblies has now accumulated 4,272 hours of engine test (Figure I.B.4.1.). These regenerator assemblies incorporate slots in the elastomer (Figure I.B.4.2.) to reduce the modulus.

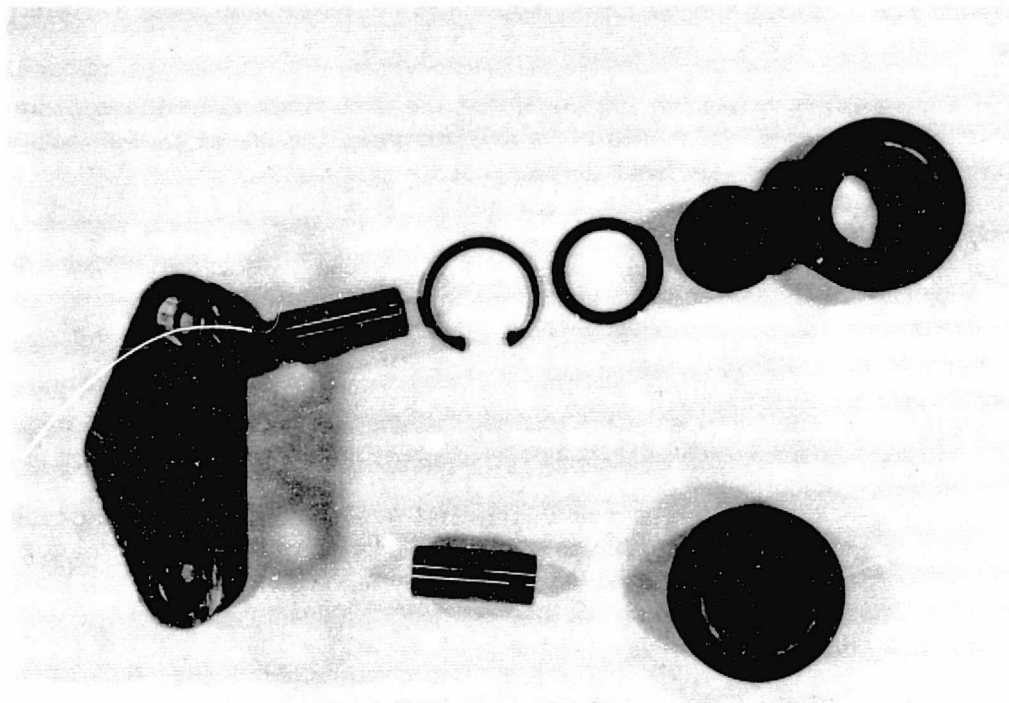
Figure I. B. 5.3

In order to eliminate the current necessity to lubricate these bearings, an experimental design concept was initiated during this report period. The new design replaces the ball bearing with a solid graphite bearing as shown on Figure I.B.5.3. This design concept was placed on test in one engine at the spring roller location, since it is lightly loaded compared to the fixed roller location. After 600 hours of engine test, the graphite bearing show no signs of distress with negligible wear.

Photograph Showing Graphite Bearing, Outer Race Support Ring, Shaft, Snap Ring, and Yoke.

Due to the encouraging results of this initial evaluation, additional graphite spring rollers will be placed on test during the next report period. In addition, a graphite design concept for the fixed roller location has been initiated.

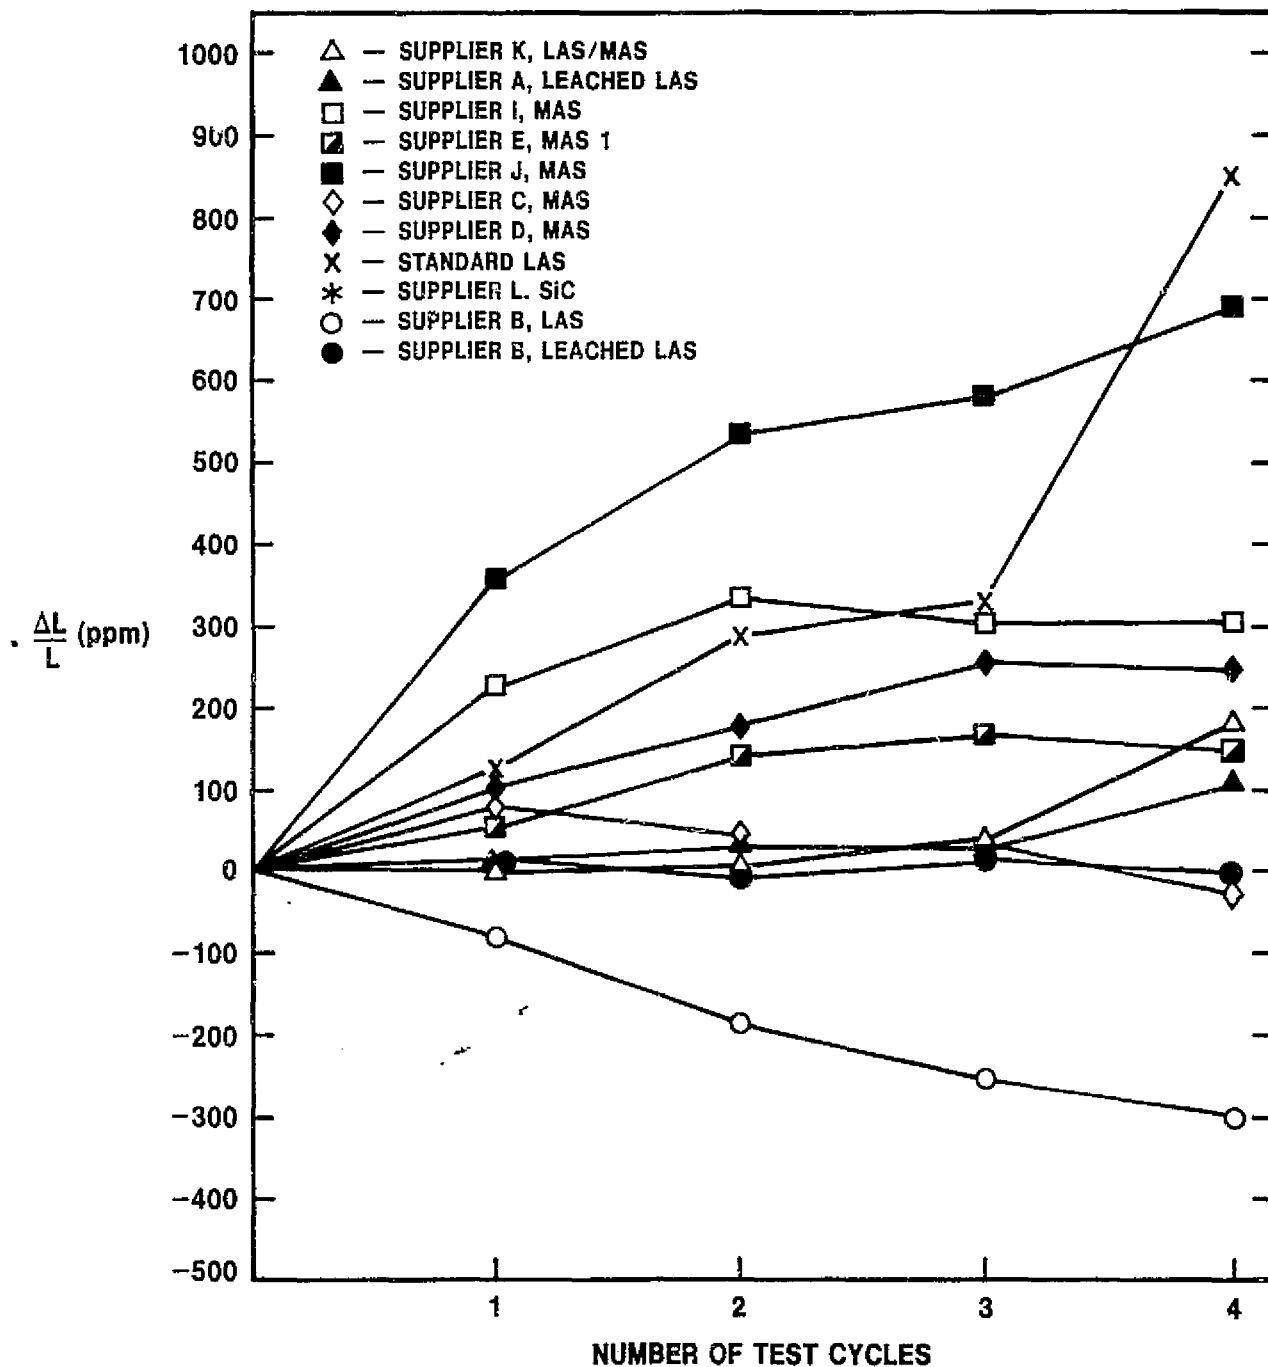
During the past reporting period, three experimental materials have completed the cold face testing program. This completes the original group selected for testing, and the data are summarized in Figure III.B.1.1. By far the majority of the materials are quite stable under the cold face test conditions. One MAS, that of Supplier J, exhibits a consistent growth trend; while the LAS material of Supplier B experiences a small, but consistent contraction. Several data points are superimposed, and these points are indicated by arrows connecting the symbols with their proper position.

Figure III. B. 1. 1 Physical Stability of Various Materials Under Cold Face Test Conditions.

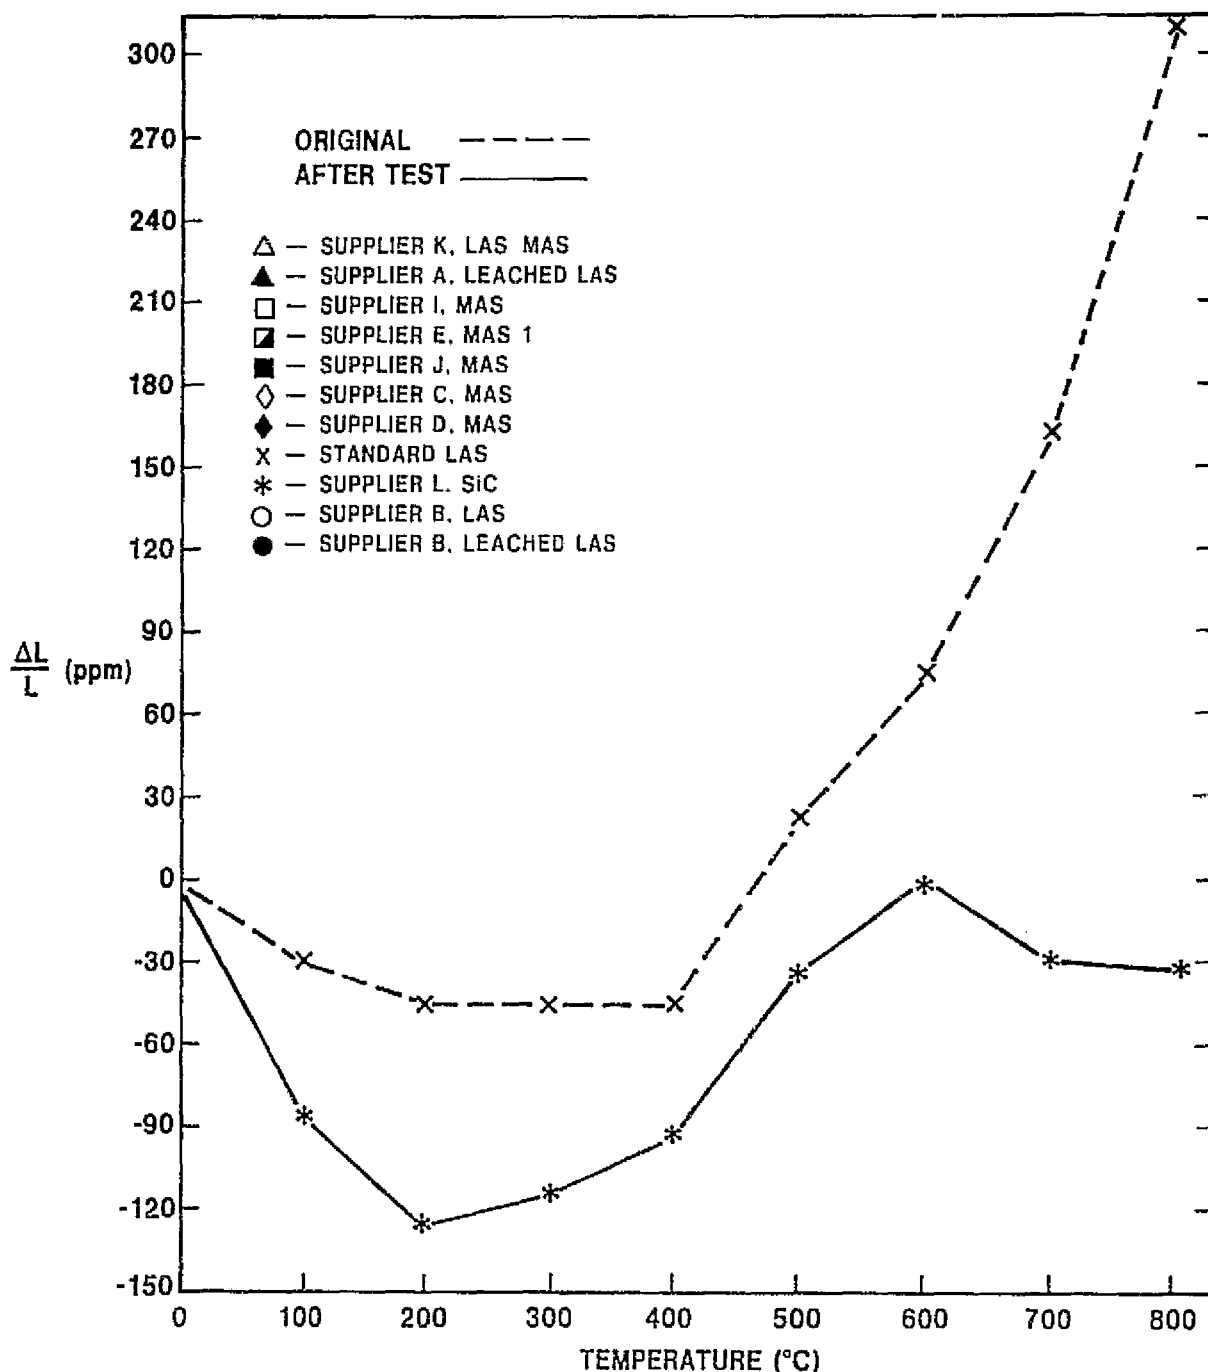
The 9455 LAS standard, which exhibits quite a bit of growth under the cold face test conditions (Figure III.B.1.1) has undergone some pronounced changes in thermal expansion behavior (Figure III.B.1.2). Obviously, the material has undergone a physical (and most likely chemical) change. Figure III.B.1.5 depicts the thermal expansion depression experienced by the LAS/MAS material of Supplier K. The basic thermal expansion behavior has not been changed by the cold face test exposure, and the test data of Figure III.B.1.1 indicate the good stability, under cold face conditions, of this material. Of interest is the opposite behavior of the two LAS materials tested under cold face conditions: the 9455 standard and the experimental material of Supplier B. The standard expanded, while the other contracted (Figure III.B.1.1). Comparing Figures III.B.1.2 and III.B.1.7, one observes quite different thermal expansion changes; in one case (the standard) the thermal expansion is severely depressed by the proton-for-lithium ion exchange promoted by the cold face test conditions. The experimental LAS has experienced just the opposite effect; the post-test thermal expansion behavior is significantly higher. The final LAS-based materials tested were two leached LAS compositions: one from Supplier A and another from

Figure III. B. 1.2 9455 LAS Standard; Thermal Expansion Before and After Cold Face Testing.

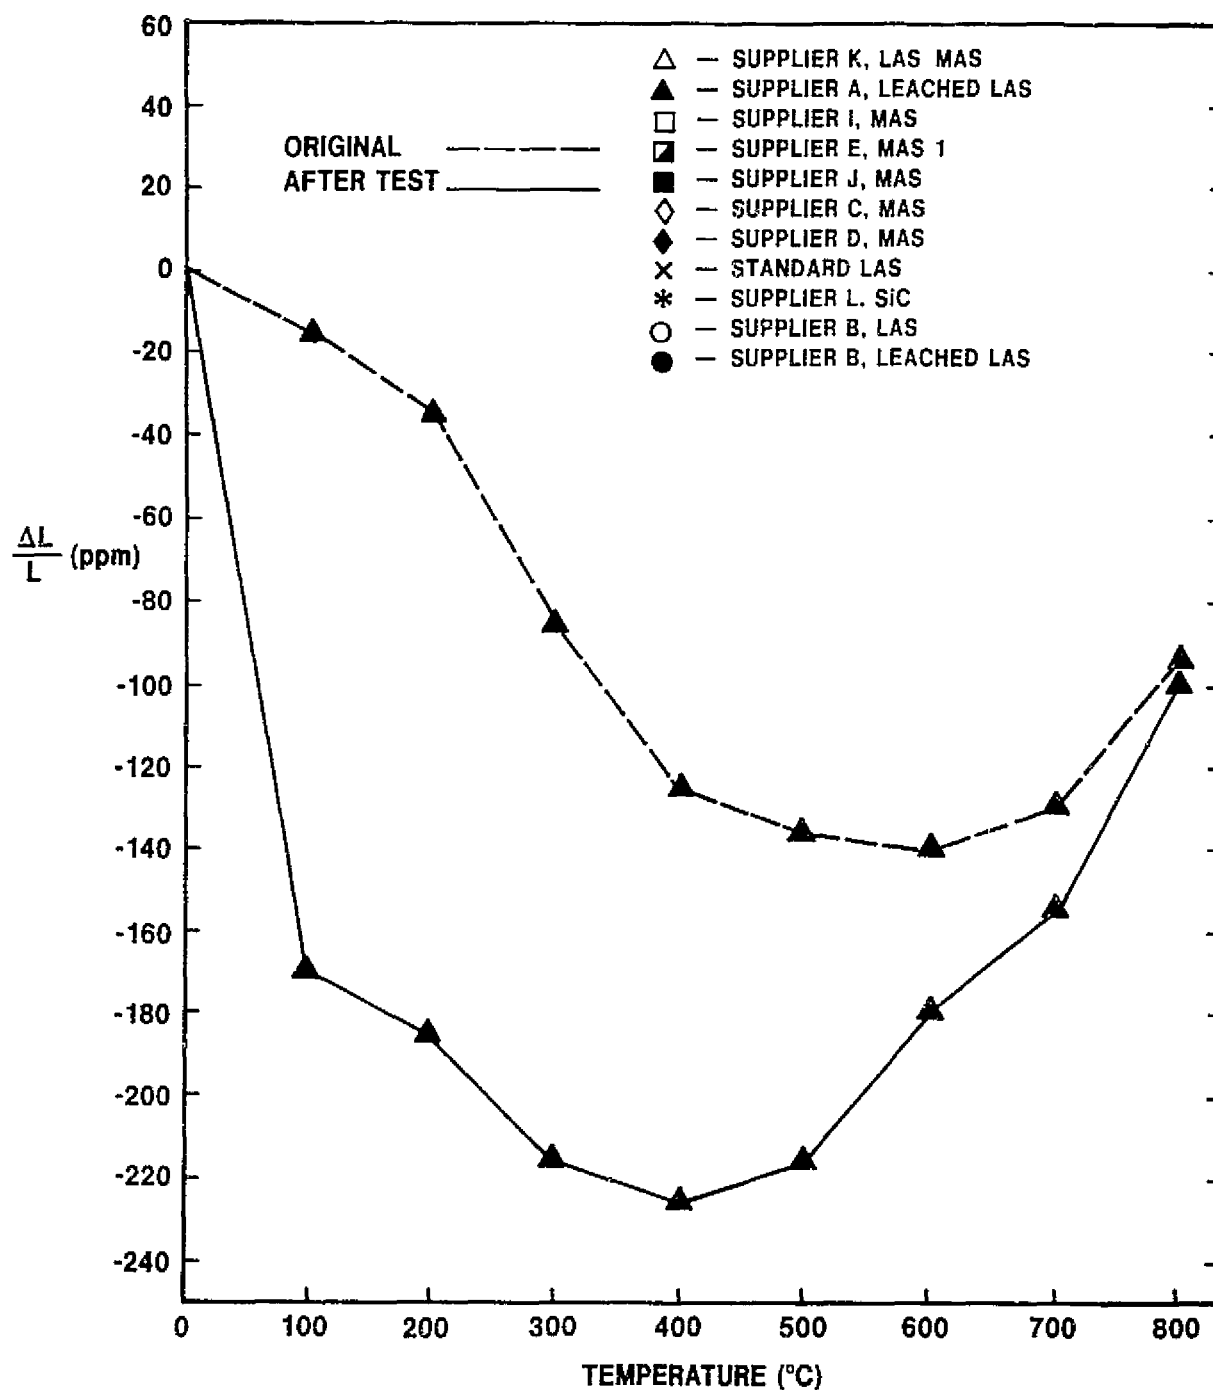
Supplier B. Again, a comparison between their respective thermal expansion data plots (Figures III.B.1.3 and III.B.1.9) with respect to the cold face test data (Figure III.B.1.1) demonstrates the inter-consistency of the data. A small amount of cold face test growth was experienced by the leached LAS of Supplier A, and the attendant depression of the thermal expansion curve suggests further leaching. This trend is suggestive of the changes experienced by the 9455 LAS standard, although the leached LAS of Supplier A is less affected and retains the character of the original thermal expansion. In contrast, the thermal expansion of the leached LAS material of Supplier B is elevated after cold face testing (Figure III.B.1.9). This material suffered little measurable change during the course of the cold face laboratory test.

Figure III. B. 1. 3 Supplier A Leached LAS; Thermal Expansion Before and After Cold Face Testing.

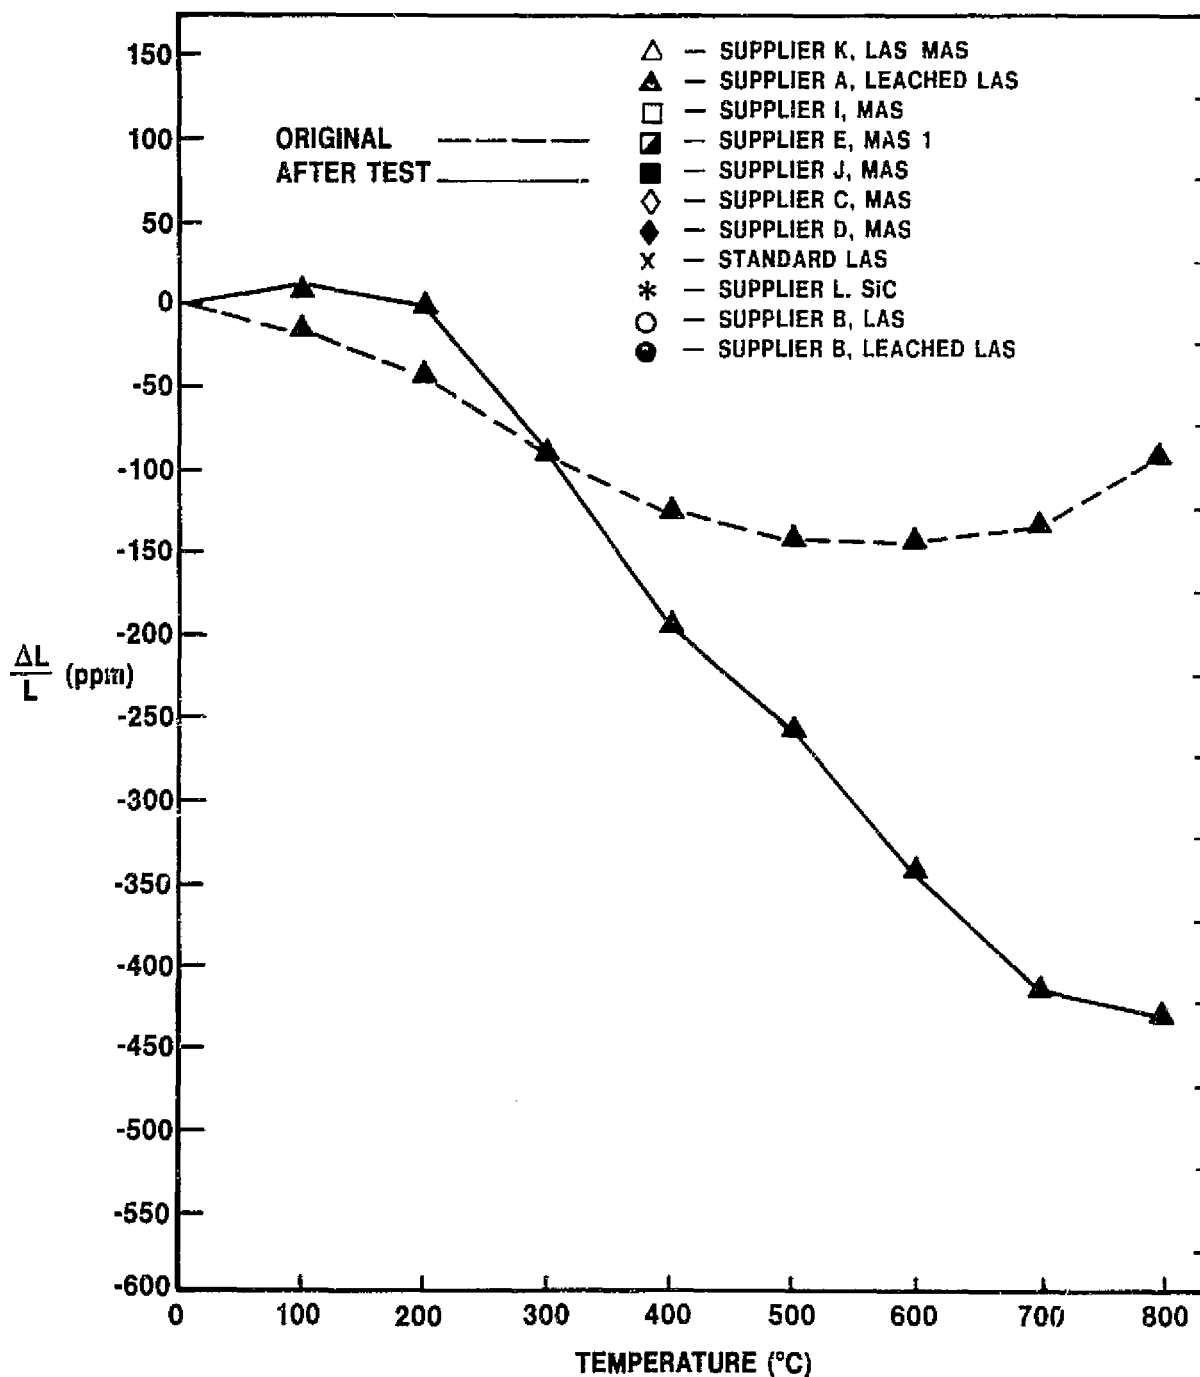
testing was quite different for the respective materials. After testing, the leached LAS of Supplier A has become more strongly contractive with increasing temperature (Figure III.B.1.14). The leached LAS of Supplier B has become slightly expansive after testing (Figure III.B.1.20). This effect is rather dramatic, as the original expansion behavior, as measured dilatometrically, was rather contractive.

Figure III. B. 1. 14 Supplier A Leached LAS; Thermal Expansion Before and After Hot Face Testing.

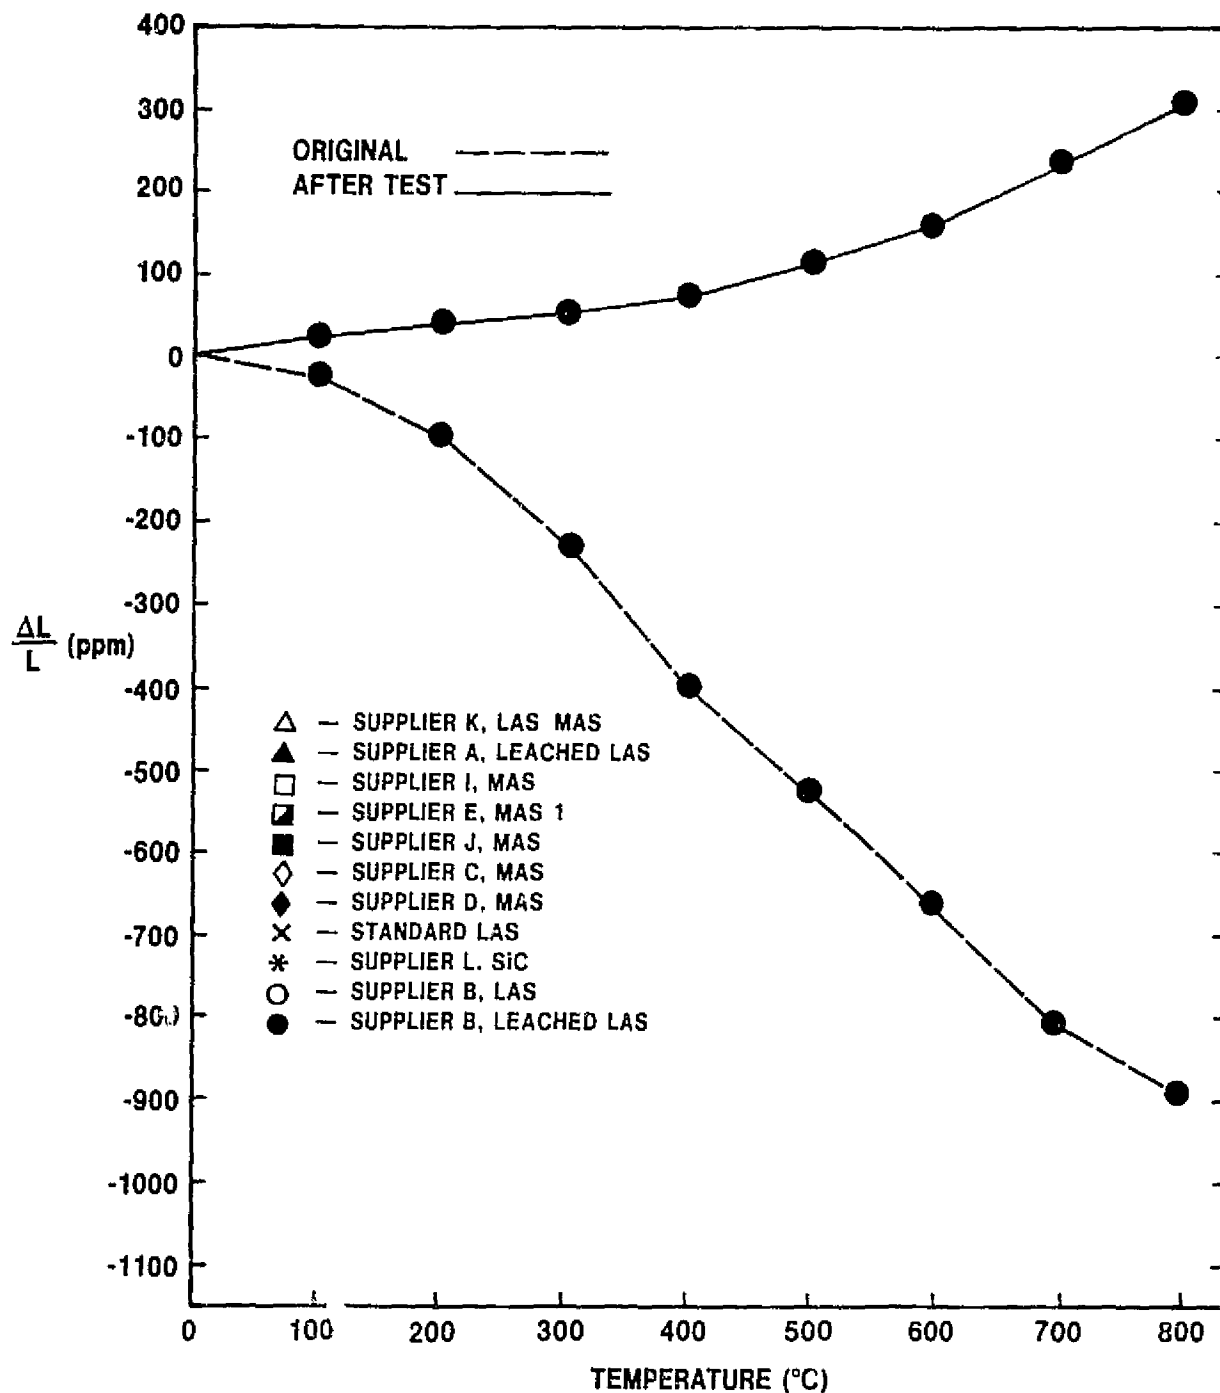
Figure III. B. 1.20 Supplier B Leached LAS; Thermal Expansion Before and After Hot Face Testing.
